Publication No.: FHWA/IN/JTRP-2002/25, SPR-2404

February 2003

Final Report

INVESTIGATION OF BRIDGE DECK CRACKING IN VARIOUS BRIDGE SUPERSTRUCTURE SYSTEMS

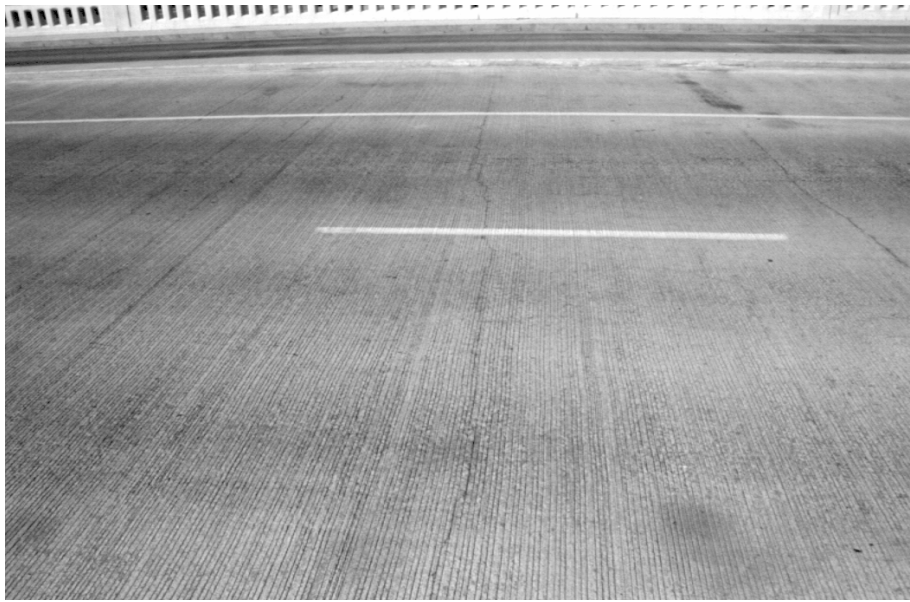
Many bridges in the state of Indiana have been identified to have cracking in the concrete deck. Cracking has been identified in the negative and positive moment regions of bridges on both the top and bottom surfaces. In some structures, only top surface cracking is visible due to the use of stay-in-place steel forms. The cracking can appear before or shortly after the opening of the structure to live loads. Significant crack widths and various degrees of cracking exist in different bridge systems including both concrete and steel superstructures. Figure 1.1 shows a bridge with multiple transverse cracks.

Figure 1.1: Transverse Cracking (Bridge 3)

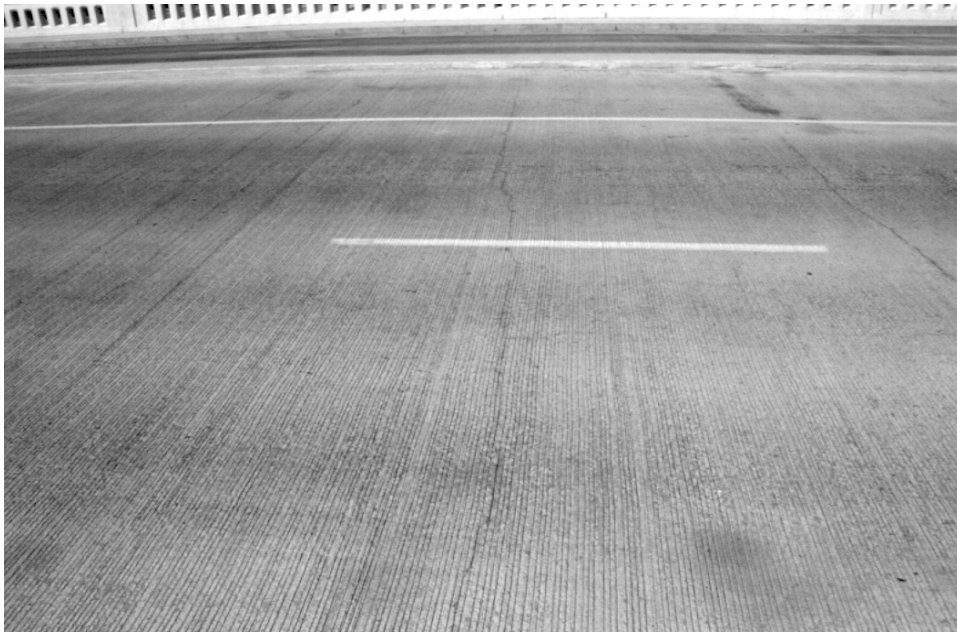
Figure 2.1: Transverse Cracking (Bridge 3)

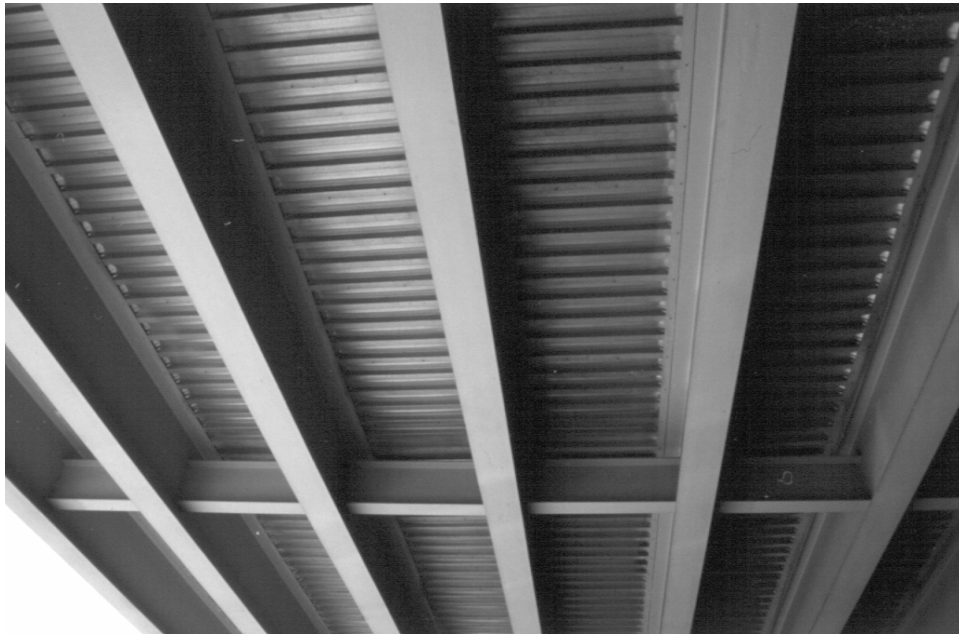
Of the bridges inspected, 7 were known to have used stay-in-place steel forms and 6 of these bridges had transverse cracks. Figures 2.2 and 2.3 show the stay-in-place steel forms. The 2-in. thick stay-in-place steel forms are corrugated galvanized steel and are screwed to a 3-in. by 2-in. galvanized cold-rolled steel angle. The cold-rolled angle was welded directly to the top flange in the positive moment region and welded to a steel bar resting on the top of the flange in the negative moment region where welding is not permissible (Figure 2.4). Figure 2.5 shows a cross section of the bridge deck slab at a girder that incorporates the use of stay-in-place steel forms.

Figure 2.2: Steel I-Beam Superstructure with Stay-in-Place Forms (Bridge 3)

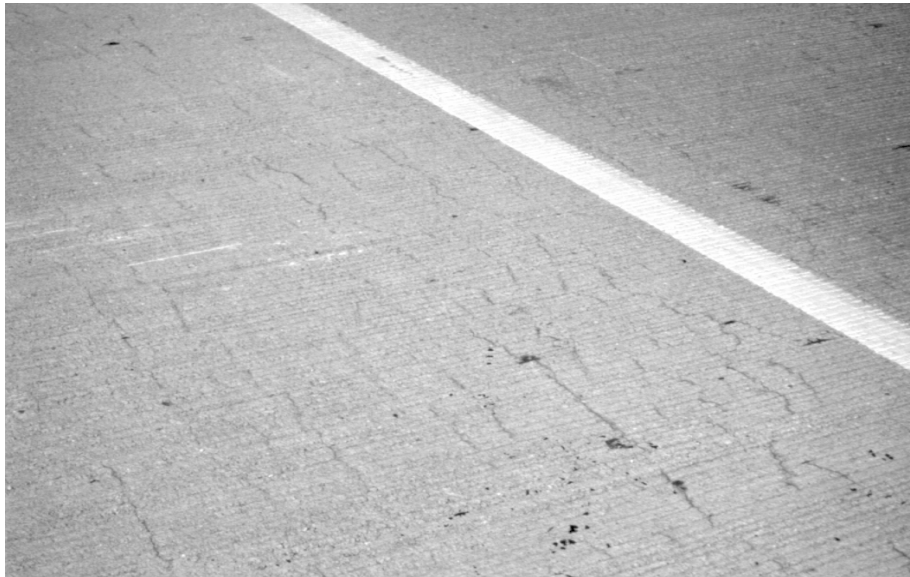
Figure 2.8: Map Cracking in Overlay (Bridge 6)

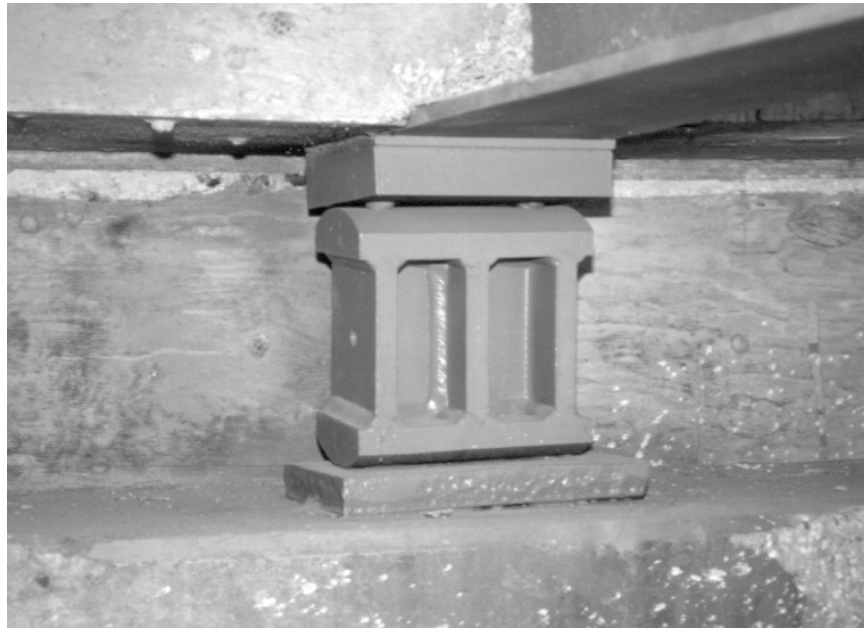
During the inspection, concerns other than deck cracking were also noted. Bridge 4 had no observed cracking on the bridge deck; however, there were several loose rockers supporting the steel I-Beam girders as shown in Figure 2.9.

Figure 2.9: Unseated Rocker Support for Steel I-Beam Girder (Bridge 4)

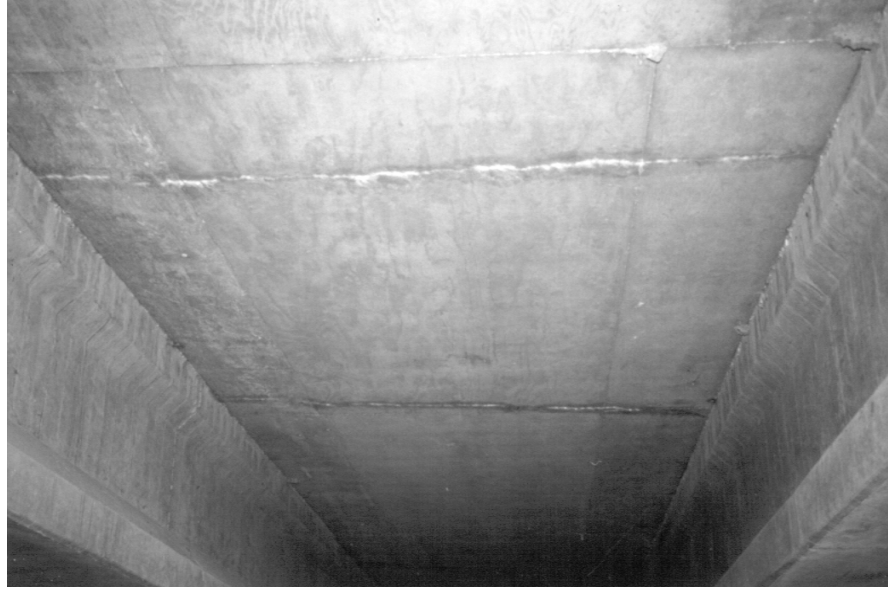
Figure 2.10: Transverse Cracks (Bridge 19)

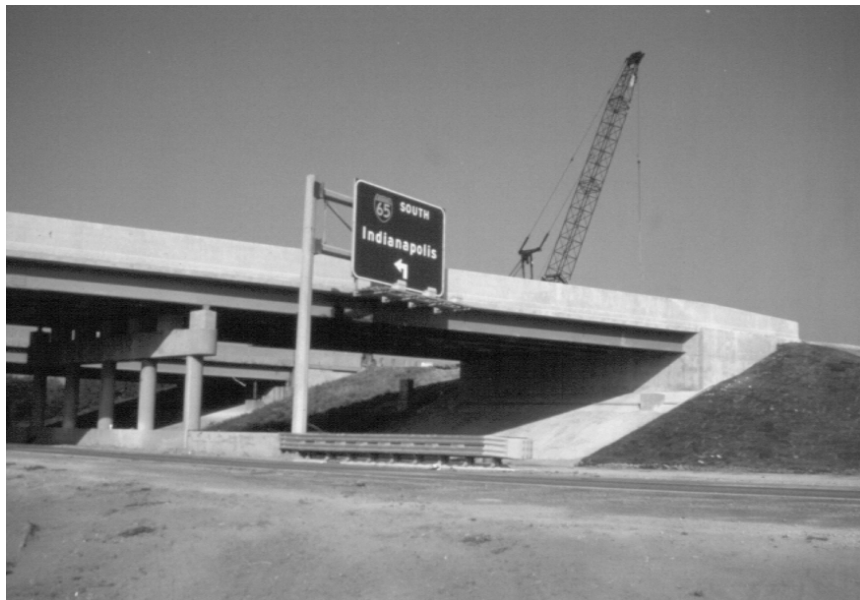
The northbound lane of Interstate 65 (I65) over State Road 25 (SR25) bridge (INDOT Bridge No. I-65-176-5543C) was selected. This bridge is a 150 ft, two-span, continuous, steel superstructure bridge, which integrates the use of composite action and stay-in-place steel forms (Figure 3.1). The bridge was originally constructed in 1969 with an overlay added in 1988. The new construction included a complete rehabilitation including deck replacement and structural modification. This bridge was designed and constructed to conform to the requirements in the *Standard Specifications for Highway Bridges*, 16th Edition (AASHTO 1996) and *INDOT Standard Specifications* (INDOT 1999). In addition, the integral end bents were designed in accordance to the *INDOT Bridge Design Memorandum #233 Revised* (INDOT 1992). Plans for the I65 over SR25 bridge deck are available in Appendix B.

Figure 3.1: Elevation of I65 over SR 25 Bridge

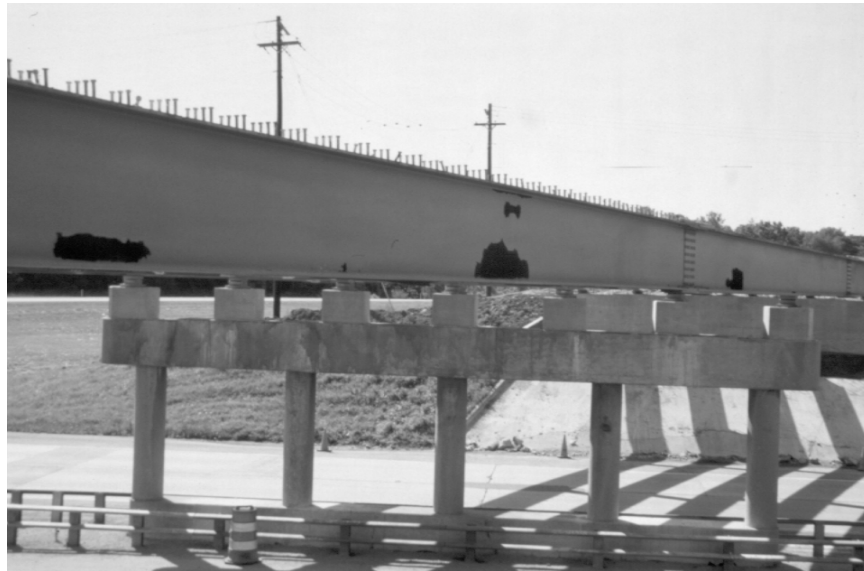
The construction sequence during the rehabilitation will be described. First, the concrete deck was removed from the steel girders. Then the girders were elevated above the end bents and supported by temporary wood piles. The entire bridge was elevated to allow for more clearance underneath the bridge because the bridge had been struck by a truck and damaged. The original end bents were replaced with integral end bents, a new standard for Indiana starting in 1999. The end bents used the existing vertical shell piles, and additional H-piles were driven. The end bents and wing walls were formed, reinforced with epoxy-coated reinforcing steel, and cast. Because the elevation of the bridge was increased, pedestals had to be cast for each of the 7 steel girders on the center pier (Figure 3.2).

Figure 3.2: Pedestals on Center Pier to Raise Elevation

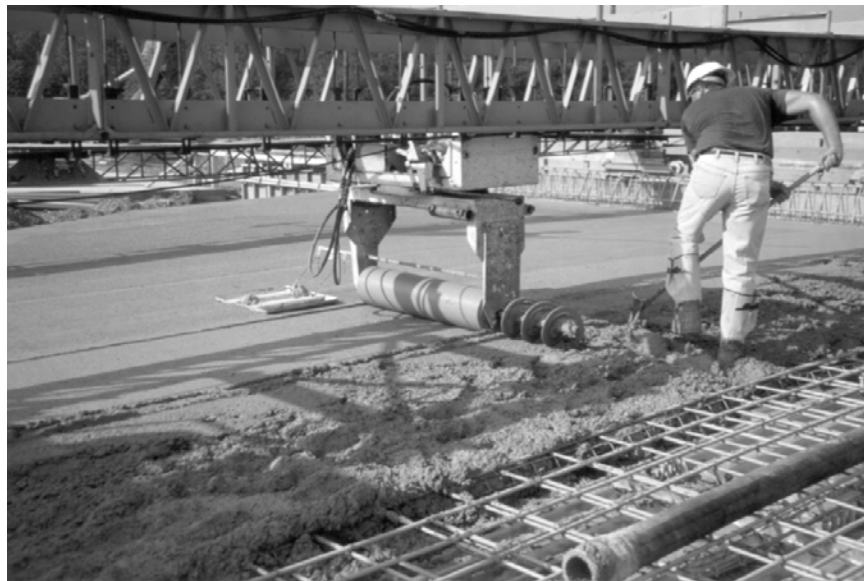
Figure 3.13: Mechanical Screeding of Deck

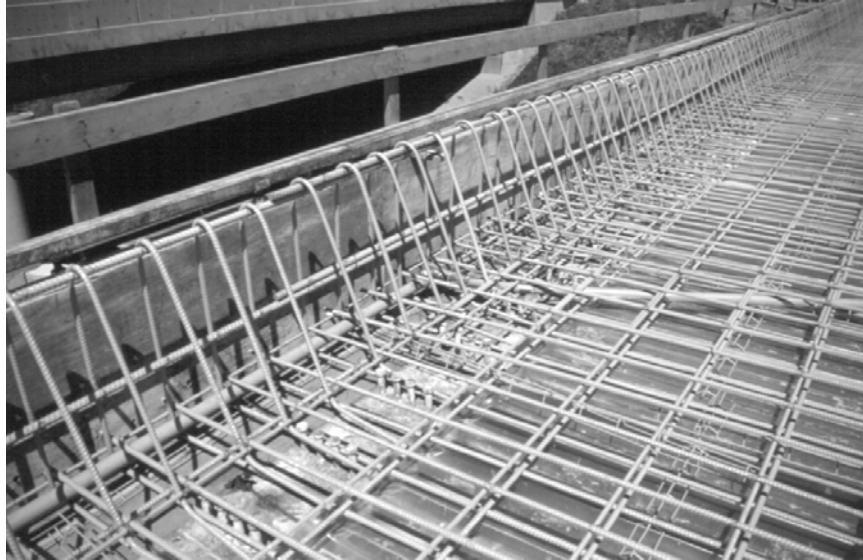
Schedule 40 electrical PVC conduits were placed in the deck to allow wires to be pulled from the datalogger systems to the strain gage and thermocouple locations (Figures 3.22 and 3.28). Conduits were placed through the end bents and data acquisition foundations prior to their casting. The conduits in the deck were placed between the 2 mats of reinforcing steel with the main conduit running in the coping line.

Figure 3.28: PVC Conduit between Mats of Steel in Deck
